Paradise Irrigation District Water Supply Recovery Program Update

May 14, 2019 Sami Kader, P.E. Water Works Engineers

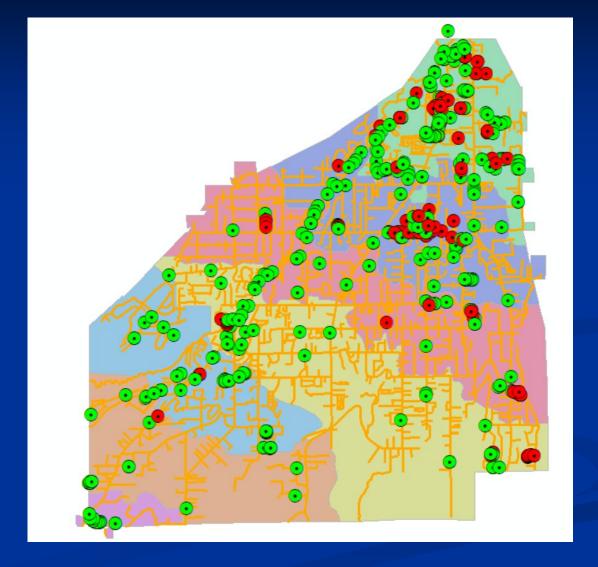
How much VOC contamination is there?

- 501 locations sampled and analyzed
- 207 VOC detect (41%)
- 109 over MCL (22%)

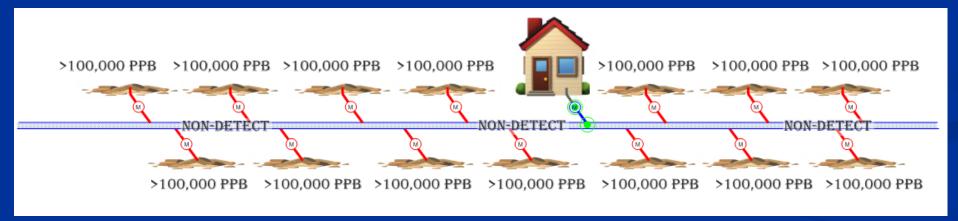
Does modeling of contaminant dispersion show that uncontaminated laterals will become contaminated?

Dispersion modeling, using Division of Drinking Water methodology, shows that even with heavy contamination of service laterals (>100,000 ppb) mains will not become contaminated via dispersion
